DI-185

DTC		Oxygen (A/F) Sensor Signal Stuck Lean (Bank 1 Sensor 1)
-----	--	--

DTC	P2196	Oxygen (A/F) Sensor Signal Stuck Rich (Bank 1 Sensor 1)
-----	-------	--

2003 TOYOTA TACOMA (RM1002U)

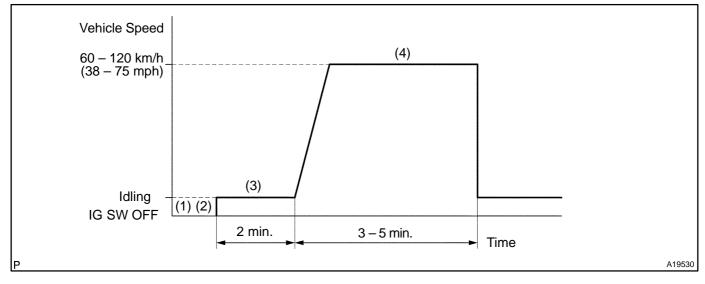
## **CONFIRMATION DRIVING PATTERN**

- (a) Connect the hand-held tester to the DLC3.
- (b) Switch the hand-held tester from the normal mode to the check mode (See page DI-3).
- (c) Start the engine and warm it up for 2 min. with all the accessory switched OFF.
- (d) Drive the vehicle at 60 120 km/h (38 75 mph) and the engine speed at 1,600 3,200 rpm for 3 5 min.

If a malfunction exists, the MIL will light up during step (d).

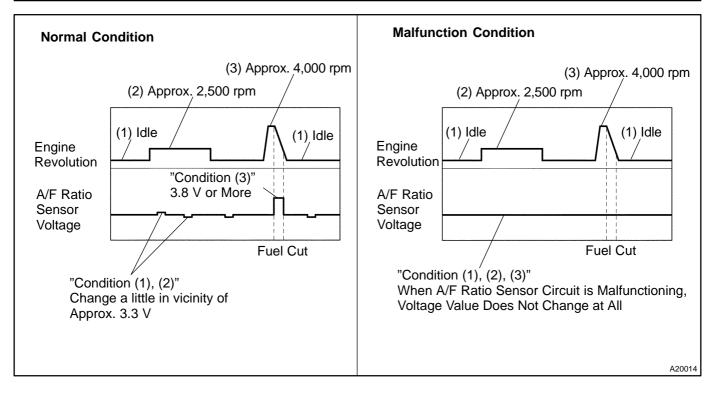
Voltage change a little in the vicinity of  $3.3 \text{ V} (0.66 \text{ V})^*$  (between approx. 3.1 - 3.5 V) as shown in the illustration.

A/F ratio sensor voltage increase to 3.8 V (0.76 V)\* or more during engine deceleration (when fuel cut) as shown in the illustration.

- Whenever the output voltage of the A/F sensor remains at approx. 3.3 V (0.660 V)\* (see dwg. 2) under any conditions as well as the above conditions, the A/F sensor may have an open-circuit. (This will happen also when the A/F sensor heater has an open-circuit.)

- Whenever the output voltage of the A/F sensor remains at a certain value of approx. 3.8 V (0.76 V)\* or more, or 2.8 V (0.56 V)\* or less (see dwg. 2) under any conditions as well as the above conditions, the A/F sensor may have a short–circuit.

- The ECM will stop fuel injection (fuel cut) during engine deceleration. This will cause a lean condition and should result in a momentary increase in A/F ratio sensor voltage.
