RS01N-32

INSPECTION

2003 TOYOTA TACOMA (RM1002U)

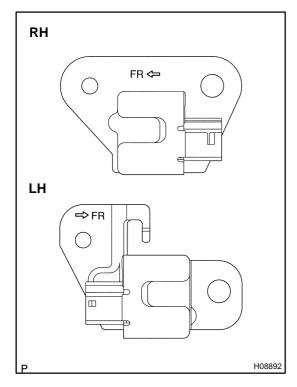
- (a) Do a diagnostic system check (See page DI-588).
- (b) If the front fender of the car or its periphery is damaged, do a visual check for damage to the front airbag sensor, which includes the following items even if the airbag was not deployed:
 - Bracket deformation
 - Paint peeling off the bracket
 - Cracks, dents or chips in the case
 - Cracks, dents, chipping and scratches in the connector
 - Peeling off of the label or damage to the serial number
